# Stabilisation of a soft fill slope by compacted rockfill – an example of good practice

Slobodan B. Mickovski

Jacobs Engineering UK Ltd., 95 Bothwell Street, Glasgow G2 7HX, Scotland, UK

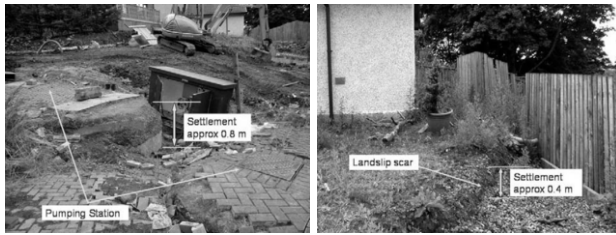
The part of residential development where the Glen Noble SPS is located was completed in 2000, when the SPS was presumably installed. Available records showed that the SPS was fully functional until noticeable ground settlement around the pumping station became evident in February 2005. On the basis of the available records and photographs, the subsidence around the SPS in 2005 is estimated to have ranged between 0.10 m and 0.60 m. The ground settlement around the SPS appeared to have increased in magnitude to 0.6 m – 0.8 m by the end of 2007, when the works described in this study began (Figure 2a).

In addition to this, during the same inspection in 2005 a tension crack (landslip backscar) became evident around 10 m to the south of the pumping station, in the garden of one of the properties adjacent to the pumping station (Figure 2b). This scar, visible over a 10.0 m length of the slope crest, ran from north to south, approximately 7.0m from and parallel to the western wall of one of the residential properties. The settlement

at the scar increased from 0.1 m– 0.2 m in 2005 to 0.4 m – 0.6 m in 2007.

Figure 2. Magnitude of settlement around the pumping station and in the garden of the adjacent house .

historical records suggested mining as a possible cause. An investigation of the available mining records obtained from The Coal Authority showed mining activity adjacent to the site. However, this mining was at depth and would have resulted in different form of settlements. A more plausible explanation for the settlement was leakage of the water pipes and seepage through the fill materials, softening and reducing shear strength, washing out fine particles and promoting settlement. This was corroborated by the Contractor's reports of displaced and broken pipes at approximately 4.0 m bgl adjacent to the PS several months prior to the commencement of the restoration works.

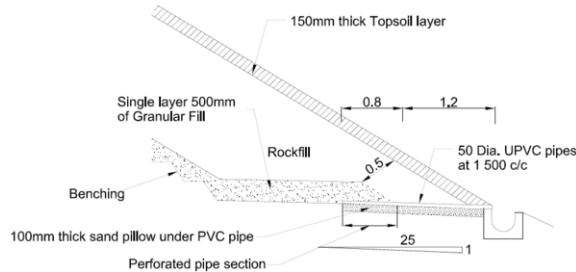
Figure 3. Typical design of filter layer and contour drain channel.

Special care was taken during the design process to allow for effective in-slope drainage in order to minimise the build-up of pore water pressures in the slope and possibly cause future instability. To this effect, 0.5 m thick granular filter layer appropriate for this grading of the rockfill (Class 6A material, grading 20-50 mm) underlining the engineered fill was designed (Figure 3). This filter layer both drained any high or perched water from the natural in-situ Glacial Till deposits and any surface seepage passing through the rockfill.

On-slope drainage was provided via a contour U-channel drain made of 1.0m long concrete sections running along the toe of the remediated slope and discharging into the new outfall structure (Figure 3; Figure 7). Permanent surface drainage in form of a new gully channel drain was installed on crest and above SPS to prevent surface water from entering the slope.

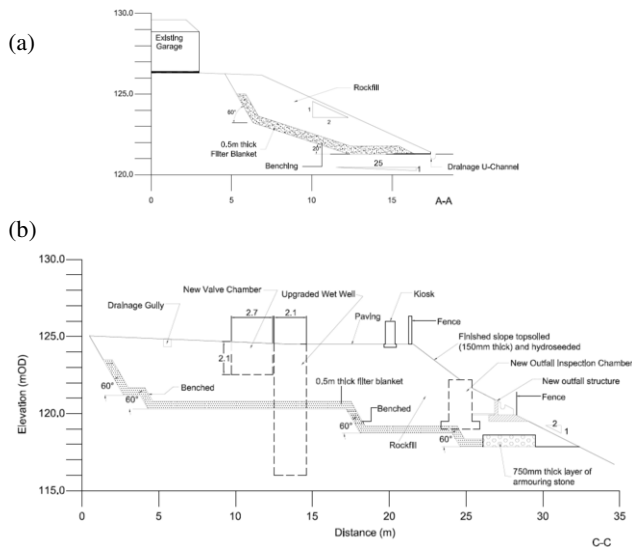
Figure 4. Magnitude of excavation and design of rockfill slope below the landslide scar (a) and around the SPS (b).

During construction, special attention was paid on the correct excavation angles for the back- and the side-cut, to ensure maximum excavated soft material at safe back-cut angles (Figure 4). All excavated slopes were benched as recommended by the Highways Agency (2007) and GEO (1984). The total excavated volume was approximately 1800 m<sup>3</sup>.

Due to the variability of the fill thickness, depth to in-situ till and/or depth to bedrock throughout the site, the thickness of compacted rockfill ranged from 2.0 m to 5.5 m, and was greatest in the area adjacent to the PS (Figure 4).

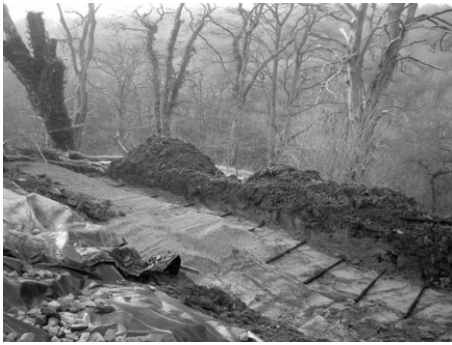
Figure 5. Laying out of the perforated drainage pipes and the filter layer.

After excavation to the base line, a 100 mm thick sand layer was laid and the perforated PVC pipes were laid on top of the sand (Figure 5). The purpose of this layer was to prevent migration of fines from the clay base and potentially blocking the drainage pipes. Granular filter layer was then laid and lightly compacted above and around the pipes, before placement of the layers of rockfill and compaction (Figure 6) in accordance with Specification for Highway Works (The Highways Agency 2009).

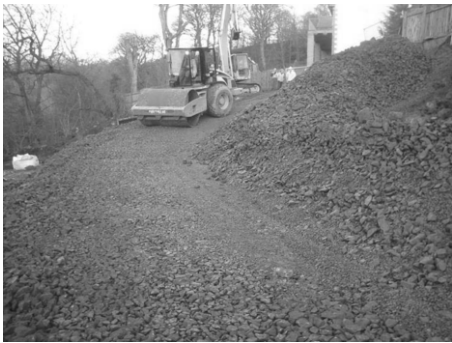
Figure 6. Compaction of the rockfill in layers.

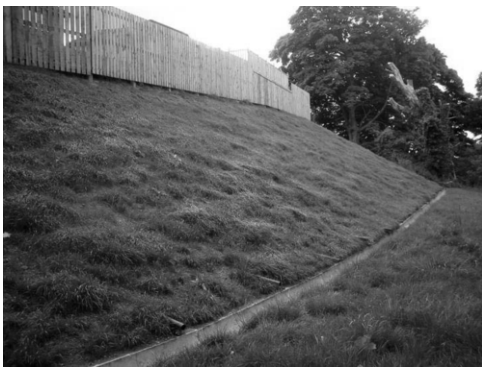
Figure 7. Completed vegetated slope with contour channel drain at the toe.

Compacted rockfill was used to stabilise a failed fill slope around and adjacent to a pumping station in a residential area south of Glasgow, Scotland. It was considered that the cause for the failed slope was connected to washout due to burst utilities. The rockfill provided advantages over the option of re-use of the existing cohesive fill such as faster, easier and safer construction. The filter layers and drainage pipes were designed remove any water entering the slope. Hydroseeding and planting has proved very successful as shown on Figure 7.
