Condition monitoring and failure analysis of liquefied natural gas plant flow control valve stem packing system

17th International Conference on Condition Monitoring and Asset Management (CM 2021)

Eloi S Pereira, Babakalli M Alkali and Octavian Niculita

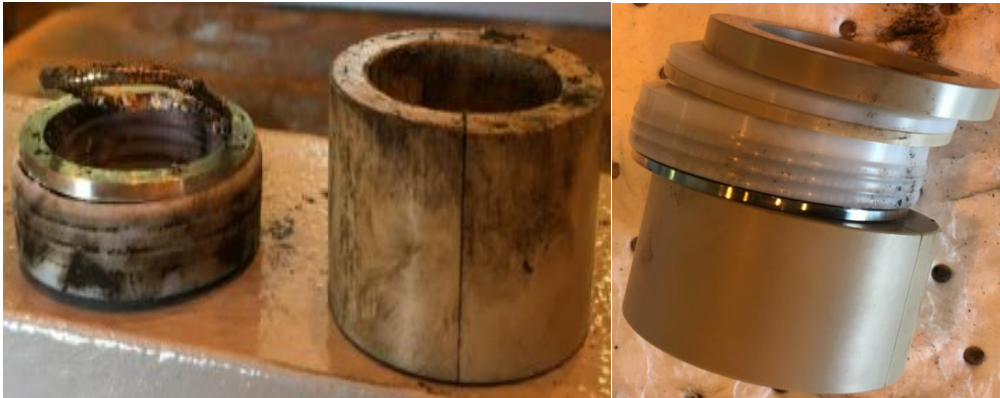
The stem packing failures described occurred primary on the backside (downstream end) of the stem. Figure 2a,b show stem wear patterns and spring failures. In an attempt to reduce the vibration and relative movement of the actuator and valve body a brace back was installed as show in figure 3. The brace have reduced the relative movement but it did not eliminate the stem packing failure. In addition (OEM) had concerns that the brace may distort and misalign the valve stem^[3].

Figure 2 (a) Failed stem packing o the left and new stem packing on the right

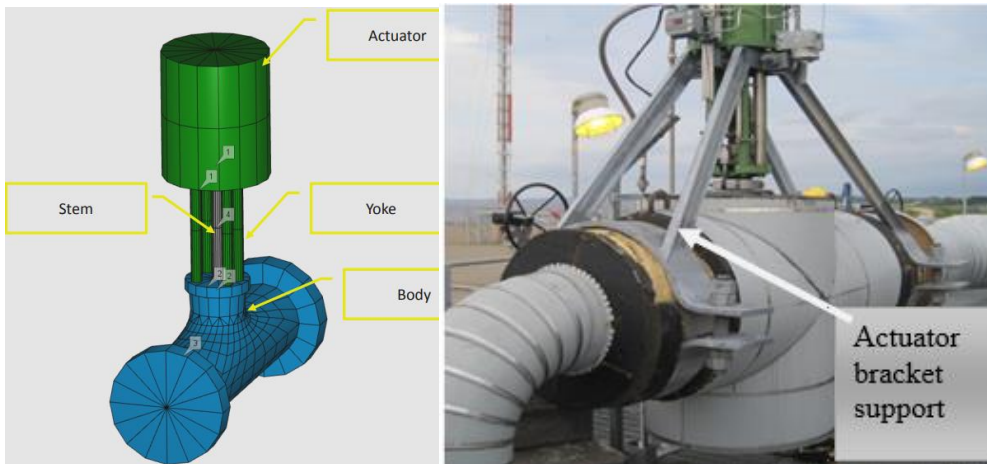
Figure 2 (b) Show an actuator bracket support installed due to the levels of vibration within the system, and the cantilevered mass of the top works.

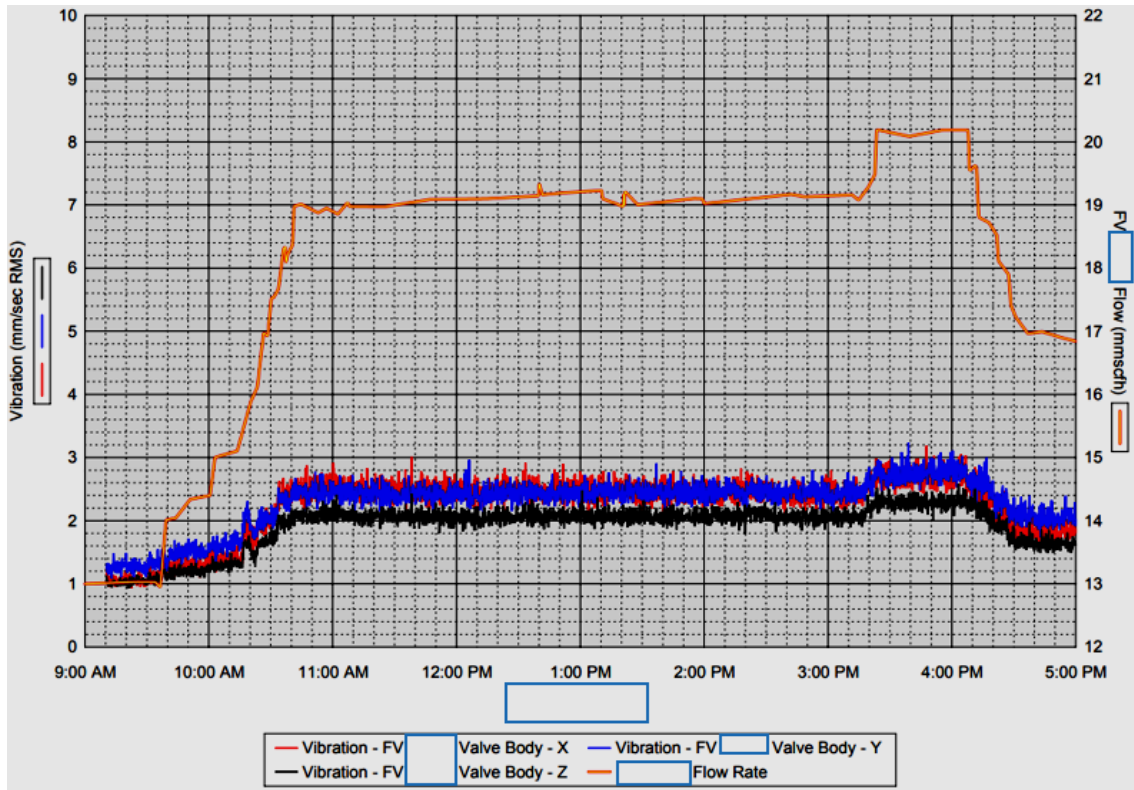
As displayed in the trend plots (figures 4 and 5) and complex wave plots (Figure 6 and 7), the vibration was sporadic in nature (not steady-state) which is a typical characteristic of flow induced turbulence. The amplitude modulation tended to increase as the flow increased. The vibration response on (FV) was broad-based banded below 50 Hz with several peaks of 5 – 8 mils peak-peak as shown in figure 8. As the flow rate through the valve was increased, an excessive amount of valve stem vertical oscillation occurred relative to the valve body, yoke. The amount of differential vibration is not linearly proportional to the increase in flow. As shown in the table 3. 3 to 6 mils peak-peak of differential motion of the valve stem occurred at the flow rate of 13 (mmscfh).

Figure 4 valve body vibration

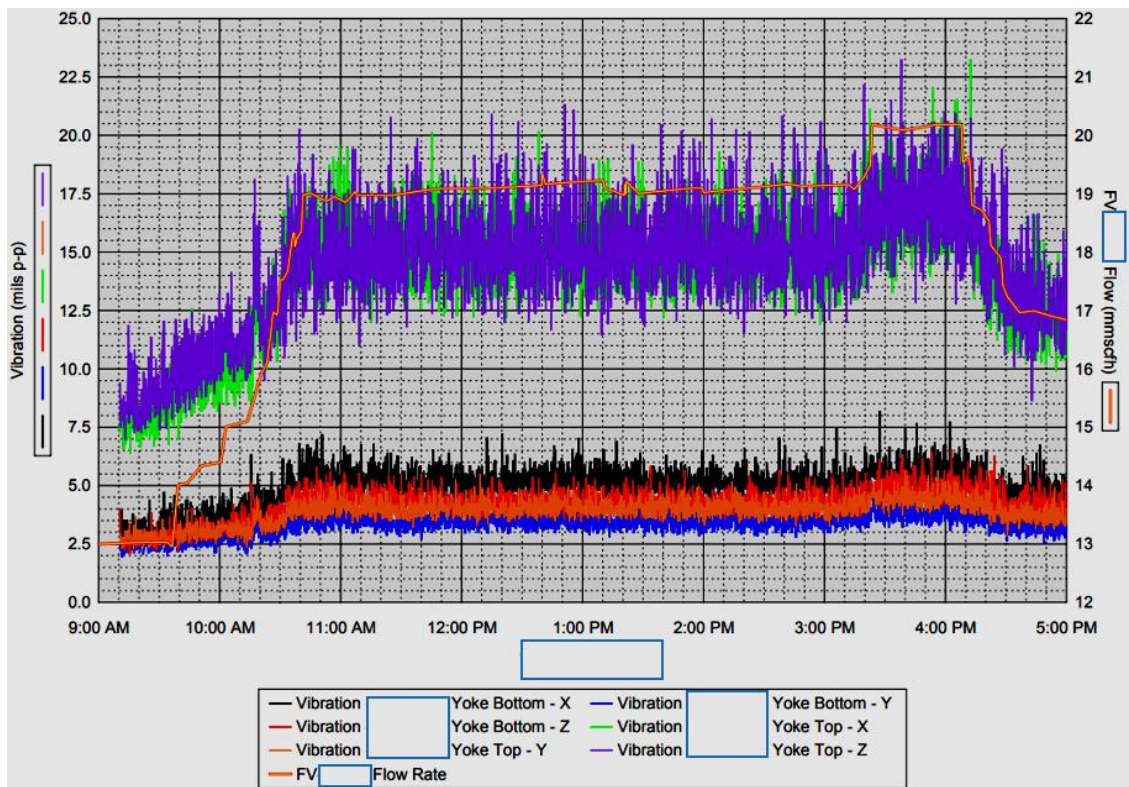
Figure 5 Valve yoke vibration

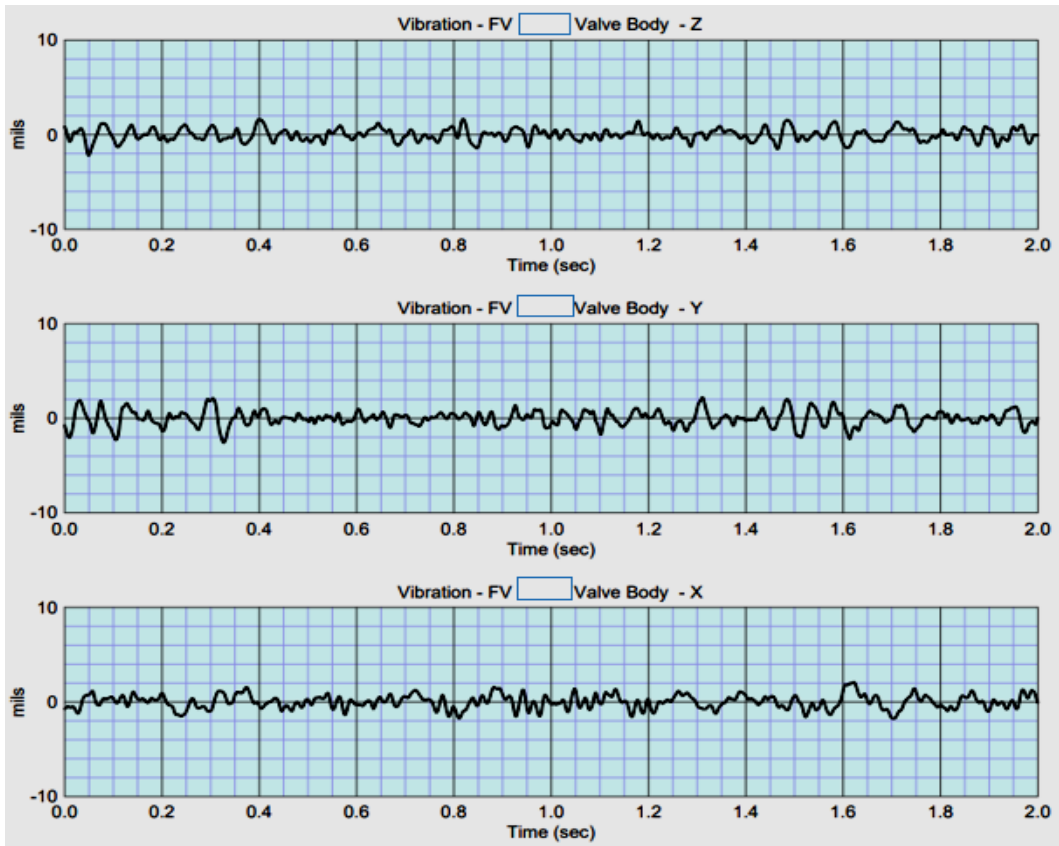
Figure 6 Valve body vibration measured at flow of 20 mmscfh

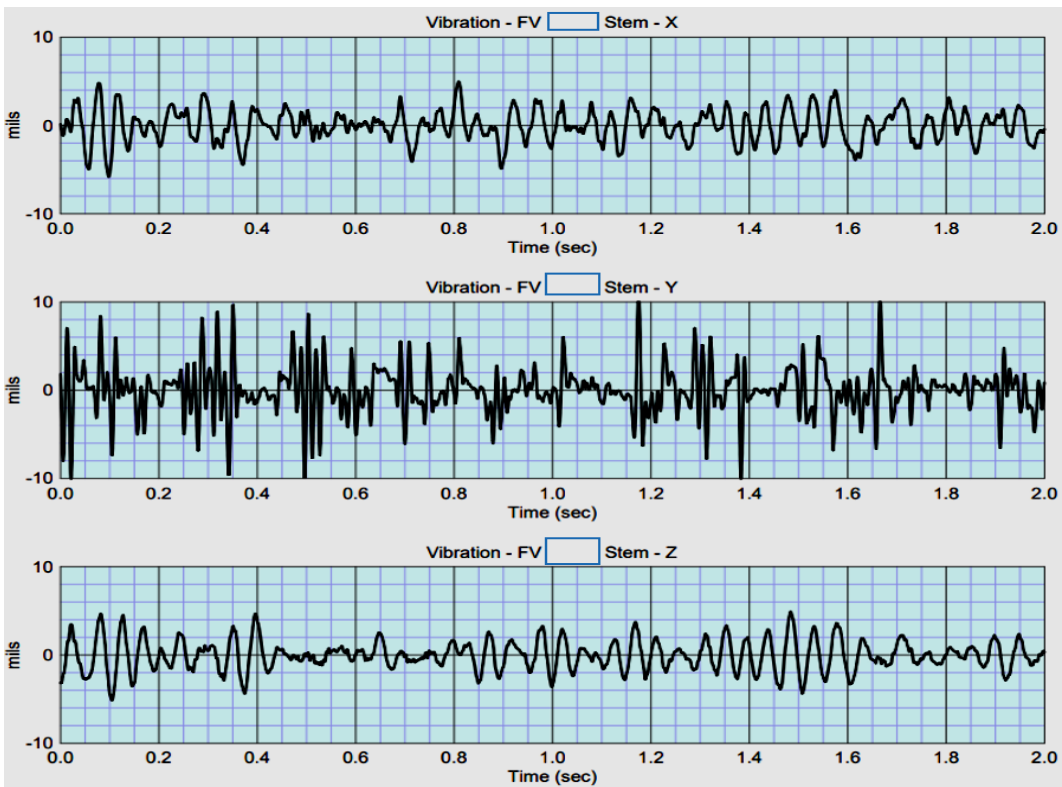
Figure 7 Valve stem vibration above coupling measured at flow of 20 mmscfh

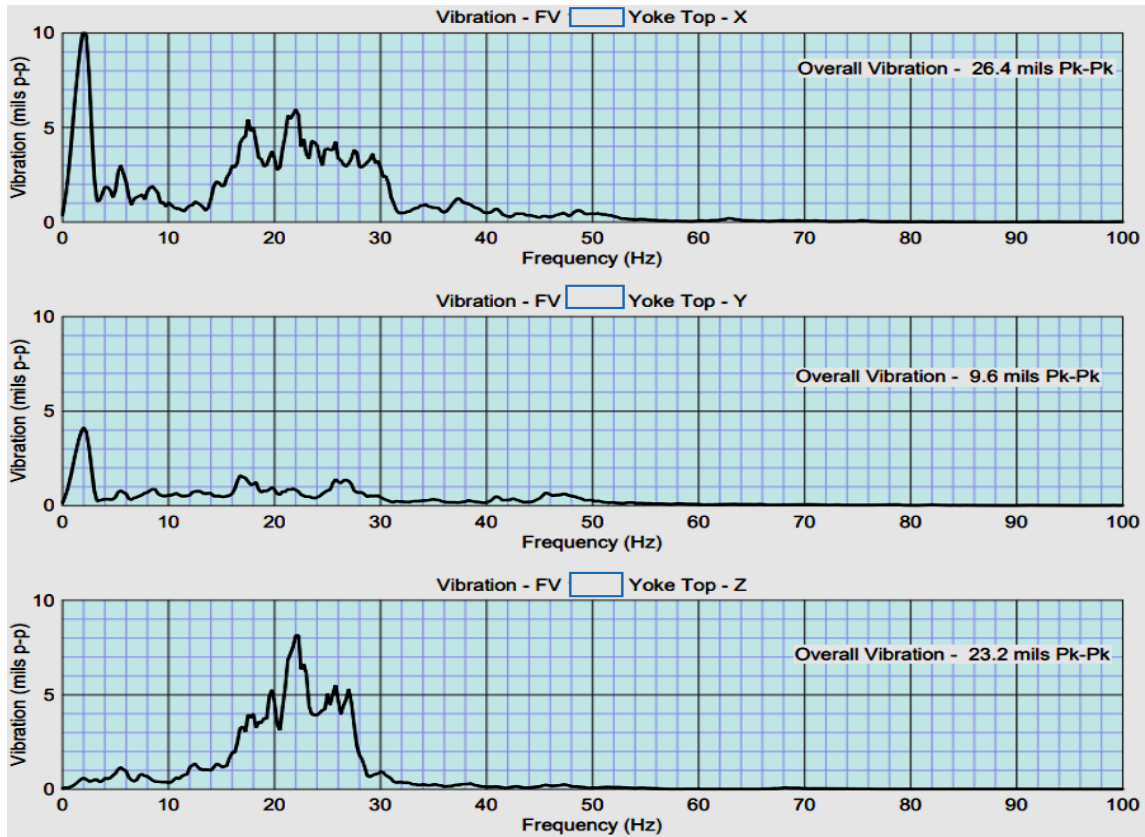
Figure 8 Valve vibration top yoke measured at flow of 20 mmscfh

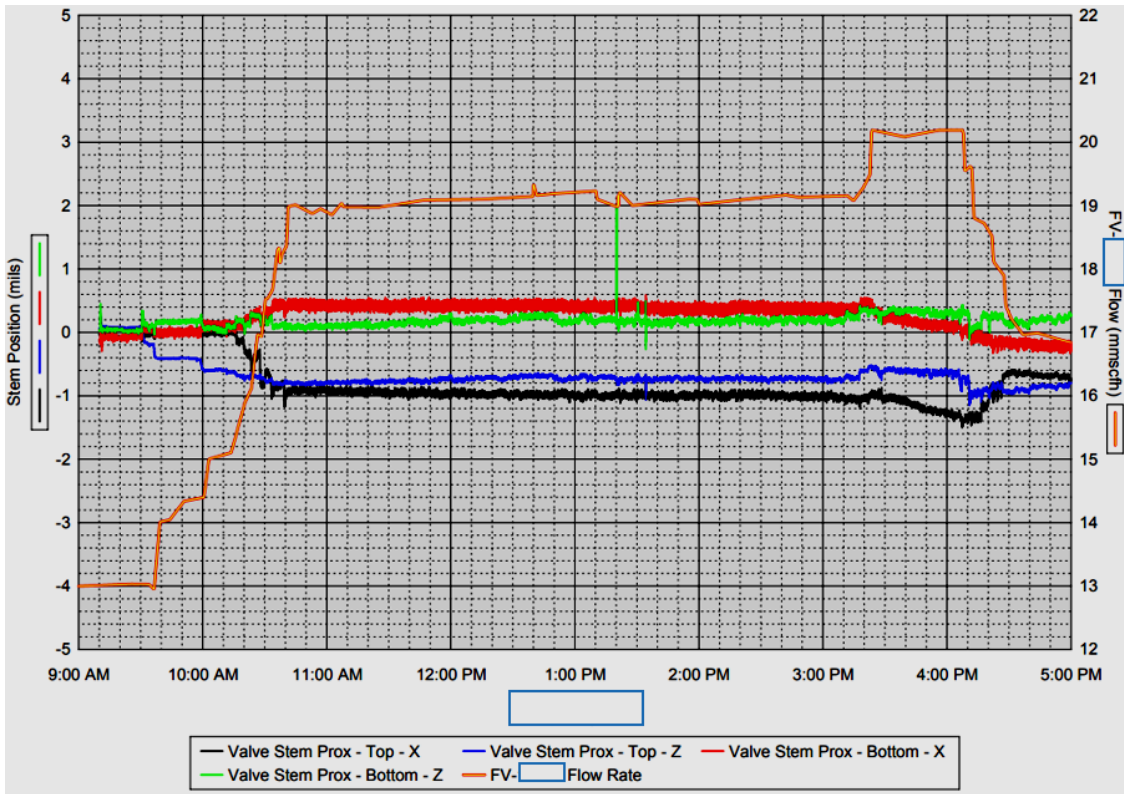
Tracking the radial relative displacement at the base of the valve stem just above the packing shows the motion was not consistent with flow; although, the movement was <0.5 mil over the 13 to 20 (mmscfh) flow range as shown in figure 5. The valve stem motion just below the operator moved approximately 1 mil to the east and 1 mil to the north as the flow was increased from 13 to 20 (mmscfh) as shown in figure 9. It is possible that some of the movement measured at the both locations may be due to a change in position as the valve was opened. Trends plots of the upstream and downstream pulsation amplitudes were sporadic, similar to the vibration characteristics. In general, both the upstream and downstream overall pulsation amplitudes varied and trended up with flow. However while maintaining a flow rate of approximately 19 (mmscfh), the downstream pulsation amplitude did increase while the upstream pulsation amplitude did not. As shown in figure 10. Frequency spectral plots of the upstream and downstream pulsation obtained at the gas flow rates of 13 (mmscfh) and 20 (mmscfh) are shown in figure 11 and 12. The noise level measured downstream of valve (FV) was approximately 83.5 dBC at the flow rate of 19-20 (mmscfh).

Figure 9 Valve Stem position

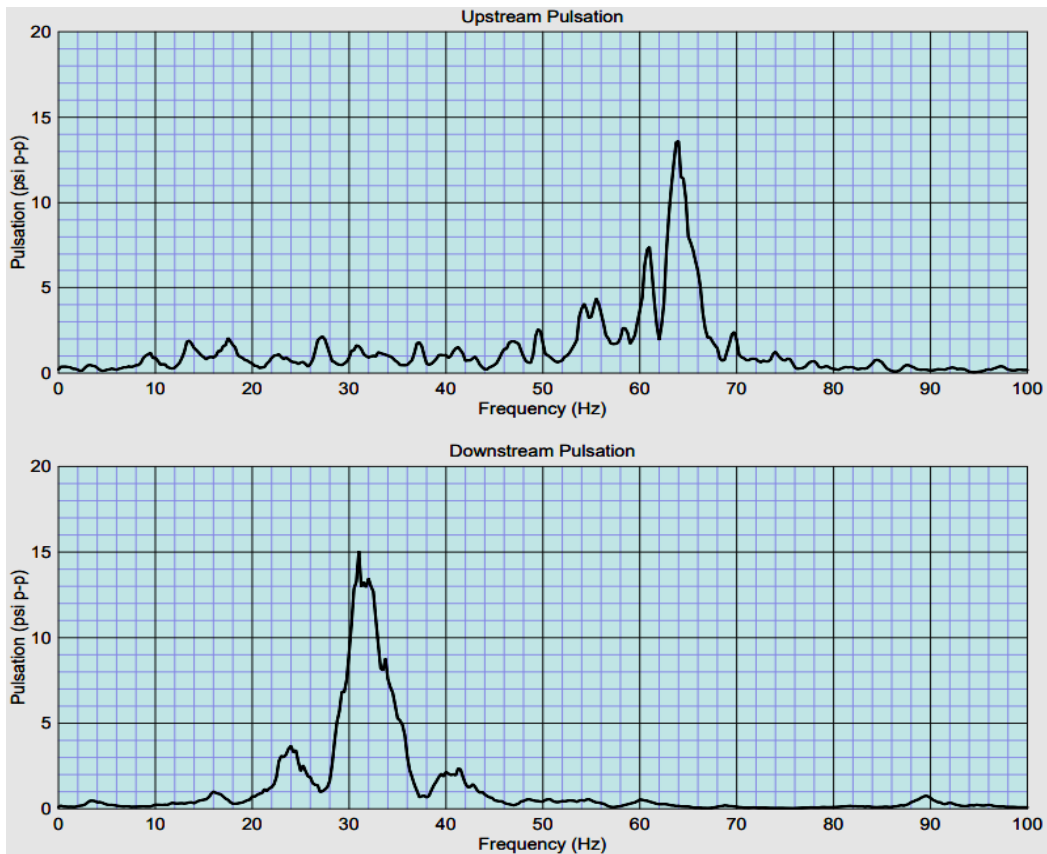
Figure 11 Valve pulsation flow at 13 mmscfh

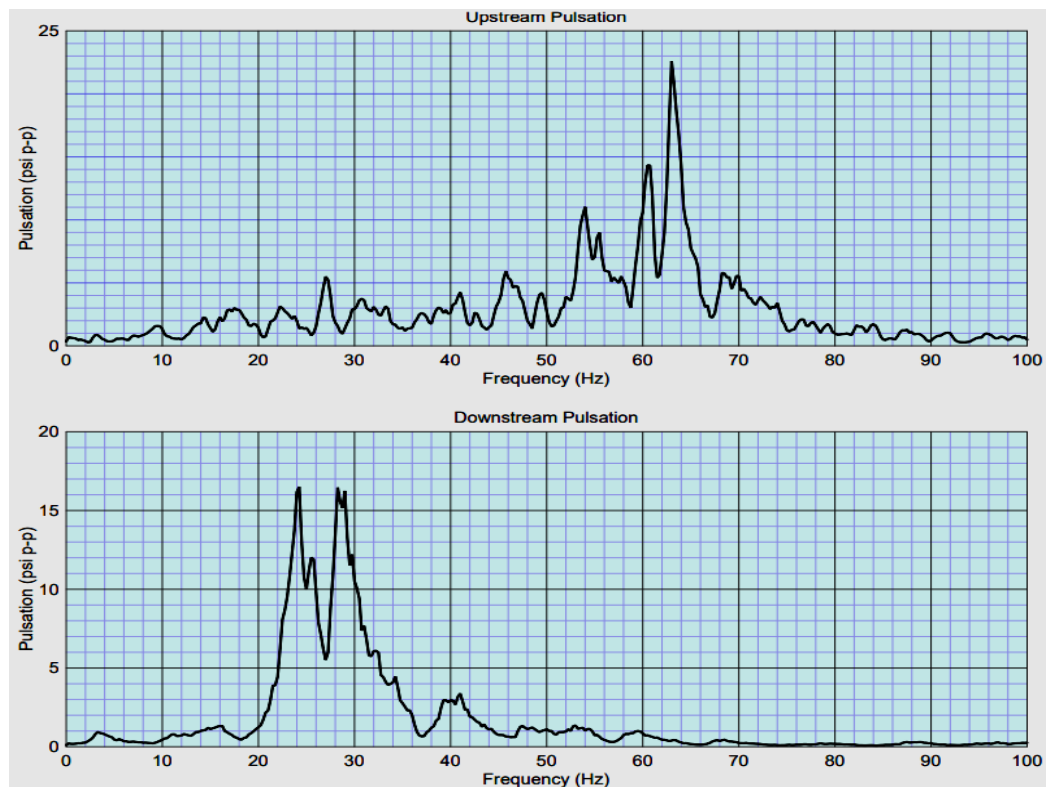
Figure 12 Valve pulsation flow at 20 mmscfh
