Diagnosis of abnormal temperature rise observed on a 275 kv oil-filled cable surface: a case study

Published in:
IEEE Transactions on Dielectrics and Electrical Insulation

Diagnosis of Abnormal Temperature Rise Observed on a 275 kV Oil-filled Cable Surface – A Case Study

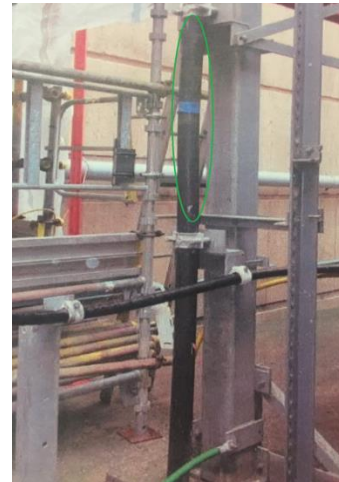
As shown in Figure 3, the Blue phase is apparently bent between two cleats which are used to fix the cable. In Nov. 2017, an inspection via infrared thermal images of the three phase cable, at 6 °C ambient temperature, revealed a local cable surface temperature rise of 5.2 °C above other phases around the bent area of Blue phase (in Figure 4). In details, the temperature of Blue phase was 17 °C which was 11 °C rise above the ambient temperature, while the temperature of the other phases were 11.8 °C which were 5.8 °C higher than the ambient temperature.

Figure 3. 275kV OF cable (Blue Phase) – the area marked in the green ellipse was observed to have a 5.2°C temperature rise.

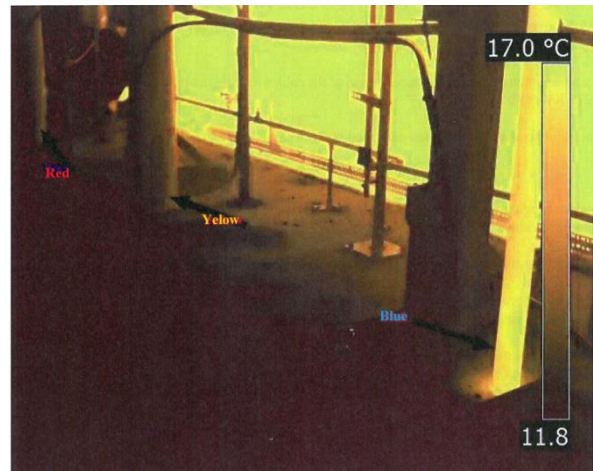
Figure 4. Infrared thermal image of the Blue Phase.

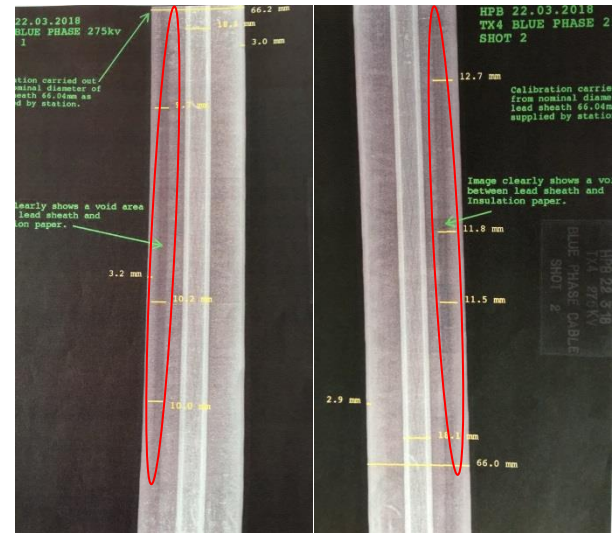
An X-ray technique was used to help researchers confirm the proposed fault diagnoses. The X-ray images were taken from both front and back side of the Blue Phase, as shown in Figure 12a and Figure 12b, respectively. Cable

construction is clearly displayed in the two X-ray images. Slight distortion of the cable can be demonstrated from inconsistent outer diameters of lead sheath, which are 66.2 and 66.0 mm respectively, and various thickness of the lead sheath which are 2.9, 3.2 and 3.0 mm respectively. The red ellipses in Figure 12a and Figure 12b show the oil region between the cable insulation and lead sheath, this has different widths at various positions.

(a) Front images (b) Rear images
– the red ellipse shows the area of oil leakage

(c) Schematic diagram of the X-ray results, a representation of the front and rear X-ray images

Figure 12. X-ray images of Blue Phase cable acquired on March 22nd 2018.

The images show that the thickness of the lead sheath varies, i.e. 3.2, 3.0 and 2.9 mm. The diameter of the conductor is shown to be 18.1 mm and the outer diameter of the lead sheath is shown to vary between 66.2 and 66.0 mm. The X-ray images also indicate a narrow region between cable insulation and lead sheath filled with oil. The lengths of the void at various positions in Figure 12a are measured as 9.7, 10.0 and 10.2 mm and in Figure 12b as 12.7, 11.8 and 11.5 mm. As shown in Figure 12c, an oil filled region between the cable insulation and lead sheath, approximately one meter in length, may have been responsible for the abnormal temperature rise. As shown in Figure 13, channels formed due to distortion and deformation allow the higher
