# Stabilisation of a soft fill slope by compacted rockfill – an example of good practice

Slobodan B. Mickovski

Jacobs Engineering UK Ltd., 95 Bothwell Street, Glasgow G2 7HX, Scotland, UK

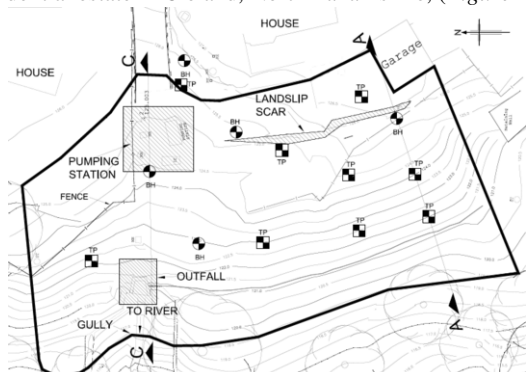
Figure 1. Site plan with marked areas of excessive settlement (shaded regions) and GI locations (BH-borehole, TP-trial pit)

The pumping station comprising a wet well, control chamber and valve chamber, is situated between two residential properties (Figure 1). The site boundary includes land owned by the local council, as well as land belonging to the individual owners of the two adjacent properties.

In absence of any historical GI records and to obtain information relevant for the design of the remedial works, a topographic survey and intrusive ground investigations comprising 5 terrier boreholes and 9 trial pits were carried out on the site (Figure 1).

Slope stability was assessed for the designed rockfill slope using strength parameters for the rockfill of  $c'=0$  kPa and  $\phi'=40^\circ$  which are on the lower bound of the typical ranges reported (Barton 1981, GEO 1984) for this type of material (grading 100-150mm,  $\gamma=20$  kN/m<sup>3</sup>). LEM analysis showed that the FS for the rockfill slope ranged between 1.43 (section through the existing landslide scar, A-A on Figure 1) and 1.49 (section through the PS, C-C on Figure 1).
