Condition monitoring and failure analysis of liquefied natural gas plant flow control valve stem packing system

17th International Conference on Condition Monitoring and Asset Management (CM 2021)

Eloi S Pereira, Babakalli M Alkali and Octavian Niculita

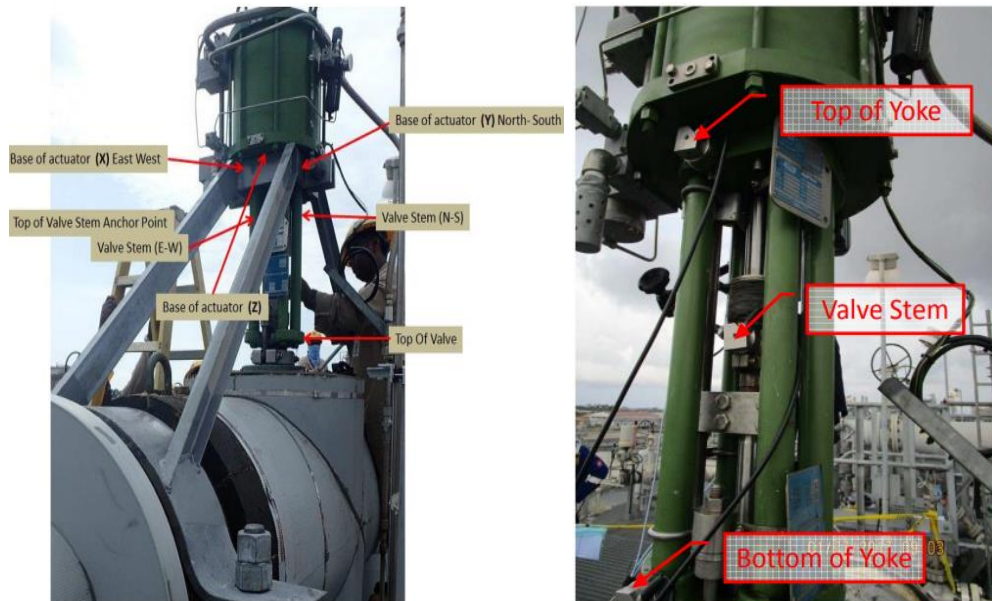
Figure 3 Vibration test points

Vibration data were acquired using magnetically mounted tri-axial accelerometers. This piezoelectric devices produces a voltage output proportional to acceleration. This acceleration signals were digitally integrated to obtain vibration in velocity and or displacement units. Figure 3 show vibration test points. Vibration data were acquired at the following locations:
