Practical methodology for the design and management of instability in hard rock tunnels

Mickovski, Slobodan B.; Pirie, Gordon

Published in:
Proceedings of the XVII ECSMGE-2019

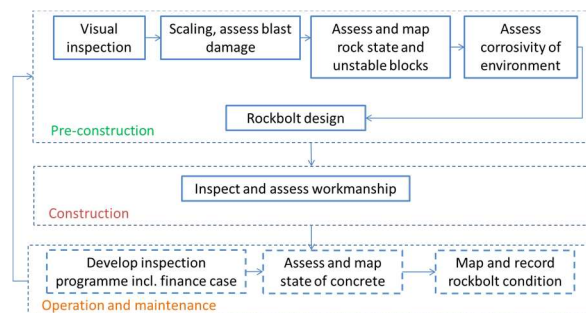
Figure 2. Proposed practical methodological framework for the design and management of instability in hard rock tunnels.

Based on the points above, a practical methodological framework for the design and management of instability in hard rock tunnels can be proposed (Figure 1). The framework is generic enough to allow for consideration of site specific features, although it is biased towards drill-and-blast tunnels where rockbolts and sprayed concrete are used for stabilisation. The tools available to the geotechnical engineer in order to combat tunnel instability will be dependent on the analysis of these features as well as on the required design life of the tunnel and the financial constraints of the tunnel owner. Although our research was limited to a number of representative case study sites and issues in Scotland and Wales, the following industry recommendations can be derived:
