Production rate of self-drilling soil nails in a coastal slope stabilisation project in Scotland

S. B. Mickovski,
Glasgow Caledonian University, Glasgow, Scotland

ABSTRACT: The aim of this study is to establish the production rate of self-drilling soil nails through different soil strata. To achieve this aim, the production rate of more than 800 self-drilling soil nails was monitored and recorded during a coastal slope stabilisation project in North-East Scotland. The recorded data was then analysed against the expected geology in order to establish the production rate in the varied soil types encountered on site which included: raised beach deposits of sands and silts, various cohesive strata comprising clays, and deeper granular deposits of gravel. The depth of installation of the soil nails ranged between 3 m and 22 m which allowed a determination of average production rate and standard deviation from the mean. The results showed that the production rate was the highest in the raised beach deposits, while most obstacles and refusals occurred in the deeper gravel deposits. The limitations of the production approach are discussed in light of the installation plant choice, the av

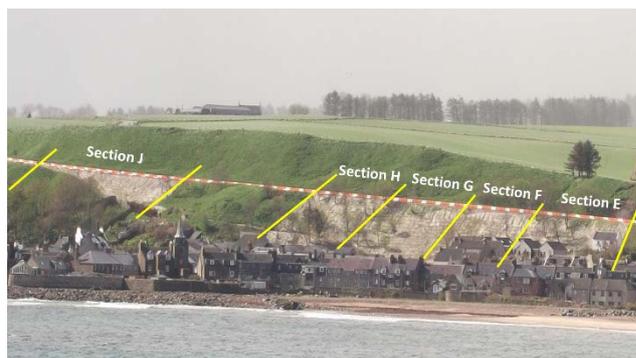
Figure 1. Site area with delineated soil nailing sections

The case study site is located in Stonehaven, northeast Scotland, forming the slope below the existing former trunk road (Bervie Braes Road), and including the adjacent coastal slope (Bervie Braes), as shown on Figure 1. The 40m high coastal slope above the old harbor in Stonehaven has a history of instability (Currie et al., 2009) which has resulted in the closure of the former trunk road bisecting the slope. The road runs sidelong and generally northwest-southeast across the Braes. For this case study, only the soil stabilization works carried out on the slope below the Bervie Braes road ('Lower slope' on Figure 2; Mickovski 2014b) will be considered.

Due to the limited budget available for the works and the available timeframe for completion of the project, the slope stabilization design comprised self-drilled hollow bar soil nails which were preferred to solid bar soil nails (Mickovski et al 2013, Mickovski 2014b). The design included soil nails with lengths of between 7 m and 24 m. The spacing between the nails was 1.5 m horizontally and 1.0 m vertically. The scope of the stabilization works was to provide the necessary resistance to erosion, shallow and deep seated (active zone of up to 10 m depth) slope failures. The design was developed based on characteristic ground profiles in five different sections of the site (Sections E-H, Section J; Figure 1), and comprised the installation of approximately 1700 self-drilling hollow bar soil nails.

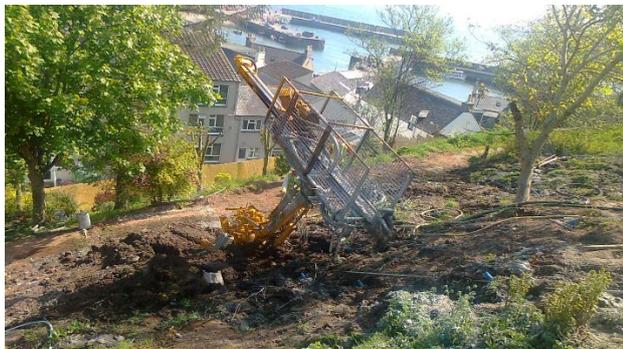
Figure 3 Soil nailing rig positioned on site. A short section of soil nail can be seen on the slope in front of the rig.

The soil nails installed in this case study comprised a 38 mm external and 19 mm internal diameter (753 mm² cross-sectional area), galvanised steel bars in mainly 3 m long sections, coupled together using galvanised steel couplers to achieve the design length and progressed using a sacrificial bit drilling a 100 mm diameter hole. The access to each nail location was cleared of vegetation and the drilling rigs were positioned at each location ensuring the safety and stability would be maintained during the construction (Figure 3)
