Published in:
Proceedings of XX ICSMGE

Production rate of self-drilling soil nails in a coastal slope stabilisation project in Scotland

S. B. Mickovski,
Glasgow Caledonian University, Glasgow, Scotland

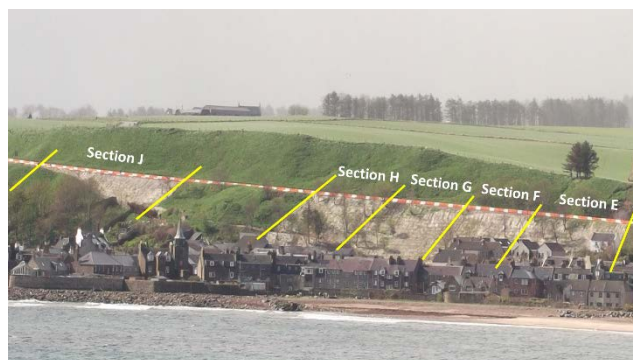
Figure 1. Site area with delineated soil nailing sections

The case study site is located in Stonehaven, northeast Scotland, forming the slope below the existing former trunk road (Bervie Braes Road), and including the adjacent coastal slope (Bervie Braes), as shown on Figure 1. The 40m high coastal slope above the old harbor in Stonehaven has a history of instability (Currie et al., 2009) which has resulted in the closure of the former trunk road bisecting the slope. The road runs sidelong and generally northwest-southeast across the Braes. For this case study, only the soil stabilization works carried out on the slope below the Bervie Braes road ('Lower slope' on Figure 2; Mickovski 2014b) will be considered.

Due to the limited budget available for the works and the available timeframe for completion of the project, the slope stabilization design comprised self-drilled hollow bar soil nails which were preferred to solid bar soil nails (Mickovski et al 2013, Mickovski 2014b). The design included soil nails with lengths of between 7 m and 24 m. The spacing between the nails was 1.5 m horizontally and 1.0 m vertically. The scope of the stabilization works was to provide the necessary resistance to erosion, shallow and deep seated (active zone of up to 10 m depth) slope failures. The design was developed based on characteristic ground profiles in five different sections of the site (Sections E-H, Section J; Figure 1), and comprised the installation of approximately 1700 self-drilling hollow bar soil nails.

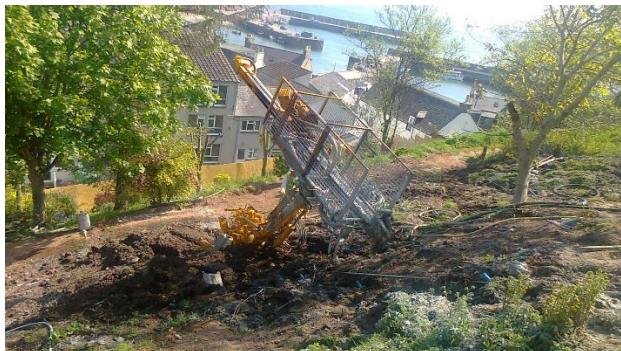
Figure 3 Soil nailing rig positioned on site. A short section of soil nail can be seen on the slope in front of the rig.

The soil nails installed in this case study comprised a 38 mm external and 19 mm internal diameter (753 mm² cross-sectional area), galvanised steel bars in mainly 3 m long sections, coupled together using galvanised steel couplers to achieve the design length and progressed using a sacrificial bit drilling a 100 mm diameter hole. The access to each nail location was cleared of vegetation and the drilling rigs were positioned at each location ensuring the safety and stability would be maintained during the construction (Figure 3)

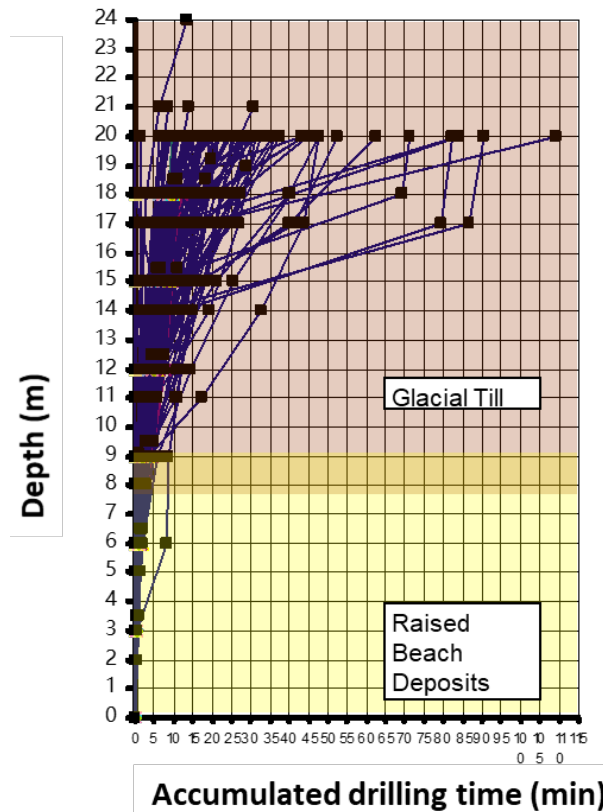
Figure 4 Drilling time required for the soil nails installed in Section E

After the test location was prepared, the drilling rig was secured in place and the nail was installed with simultaneous grouting under gravity during progress with air flush. With the exception of few outliers in each section, the installation time per nail ranged between 2 and 60 minutes in Section E, between 1 and 110 minutes in Section F, between 1 and 90 minutes in Section G, between 3 and 50 minutes in Section H, and between 1 and 50 minutes in Section J.

The production rates of soil nails varied between the sections depending on the underlying geology and the depth of installation. In section E, there were 321 nails installed at design depths of between 17 m and 20 m. Within this section, it took between 0.26 and 1.14 minutes to progress one linear metre of nail in the Raised Beach Deposits, and between 0.27 and 9.25 minutes to progress one linear metre of nail in the Glacial Till. On average, in this section, the rate of progression was 3.45 m/min in the Raised Beach Deposits and 0.65 m/min in the Glacial Till.

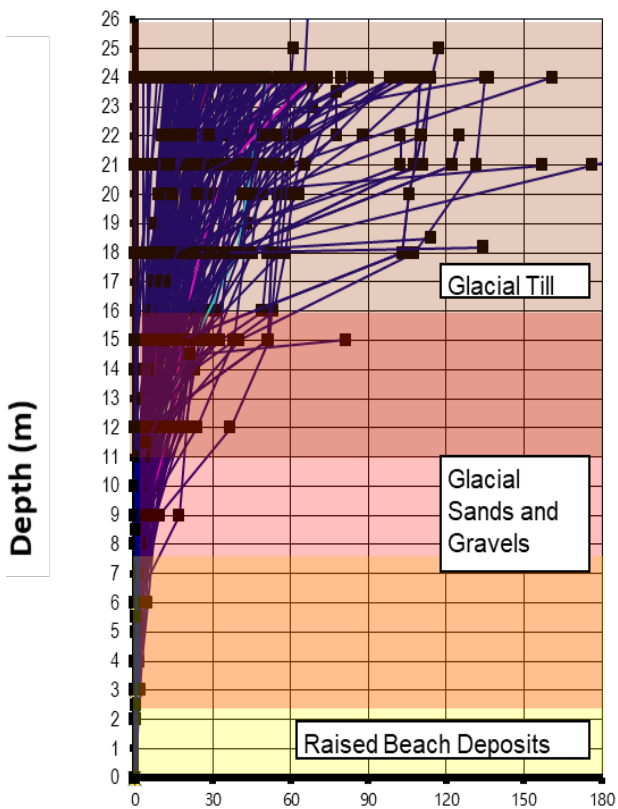
Figure 5 Drilling time required for the soil nails installed in Section F

In section F, there were 290 nails installed at design depths of between 10 m and 24 m. Within this section, it took between 0.10 and 0.45 minutes to progress one linear metre of nail in the Raised Beach Deposits, between 3.0 and 20.4 minutes to progress one linear metre in the Glacial Sands and Gravels, and between 0.45 and 13.37 minutes to progress one linear metre of nail in the Glacial Till. On average, in this section, the rate of progression was 5.0 m/min in the Raised Beach Deposits, 0.75 m/min in the Glacial Sands and Gravels, and 0.27 m/min in the Glacial Till.

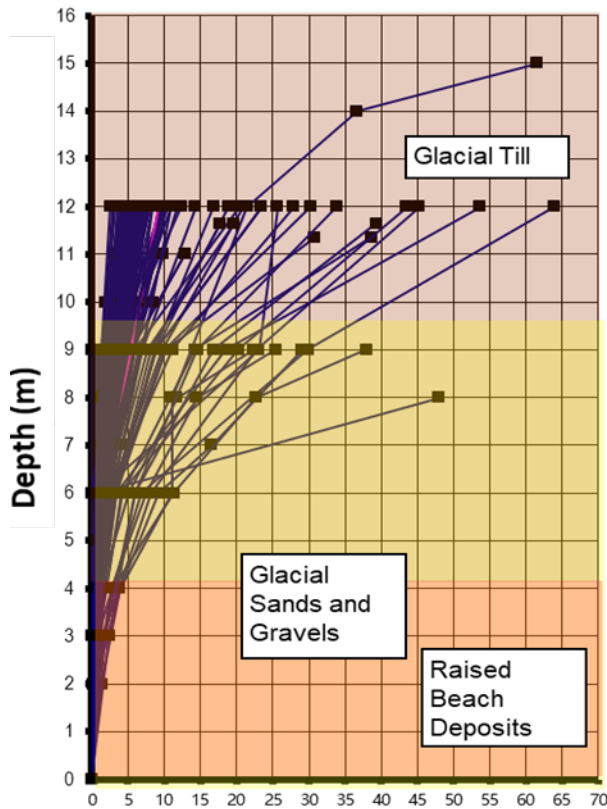
Figure 7 Drilling time required for the soil nails installed in Section H

In section H, there were 508 nails installed at design depths of between 9 m and 12 m. Within this section, it took between 0.025 and 1.5 minutes to progress one linear metre of nail in the Raised Beach Deposits, between 0.32 and 1.1 minutes to progress one linear metre in the Glacial Sands and Gravels, and between 0.10 and 11.75 minutes to progress one linear metre of nail in the Glacial Till. On average, in this section, the rate of progression was 2.82 m/min in the Raised Beach Deposits, 1.71 m/min in the Glacial Sands and Gravels, and 0.21 m/min in the Glacial Till.

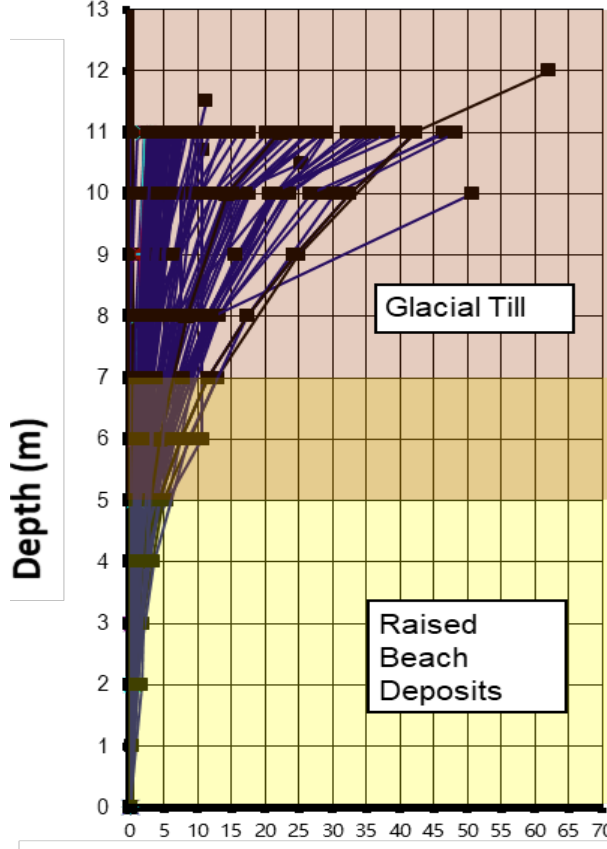
Figure 8 Drilling time required for the soil nails installed in Section J

In section J, there were 253 nails installed at design depths of between 7 m and 11 m. Within this section, it took between 0.17 and 1.71 minutes to progress one linear metre of nail in the Raised Beach Deposits, and between 0.29 and 9.01 minutes to progress one linear metre of nail in the Glacial Till. On average, in this section, the rate of progression was 4.0 m/min in the Raised Beach Deposits and 0.19 m/min in the Glacial Till.
